The South Oculus Window of Canterbury Cathedral

The preservation of a unique medieval
work of art and engineering

Leonie Seliger ACR, Head of Stained Glass Conservation, Canterbury Cathedral
6/28/2011

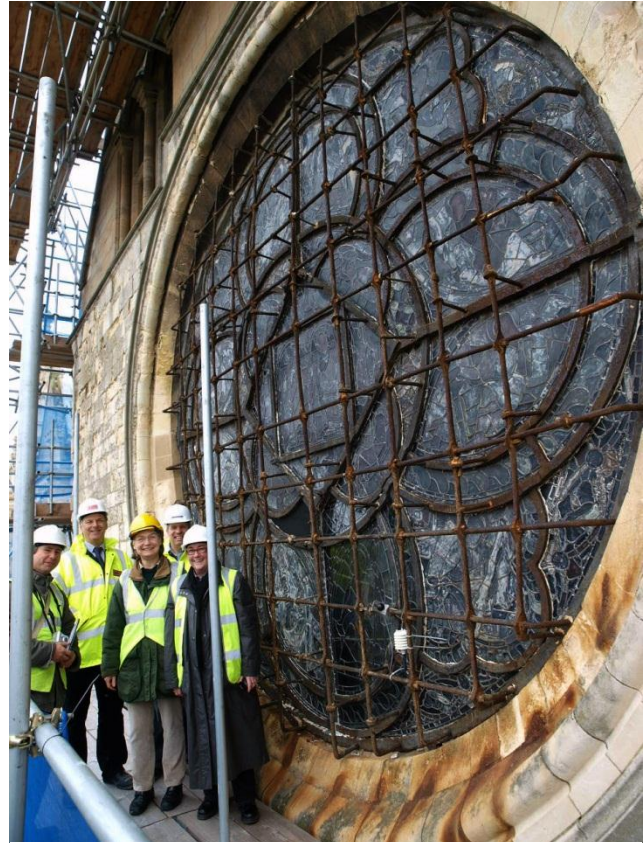
Fig.1: The exterior medieval ‘space frame’ on the South Oculus window

The South Oculus Window also represents an exceptionally important example of a medieval work of art combined with sophisticated medieval engineering. The metalwork supporting the stained glass forms a medieval space frame construction, making this by far the earliest and largest known surviving example of such an engineering solution in Europe (fig.1). An identical space frame existed on the North Oculus, but does not survive.

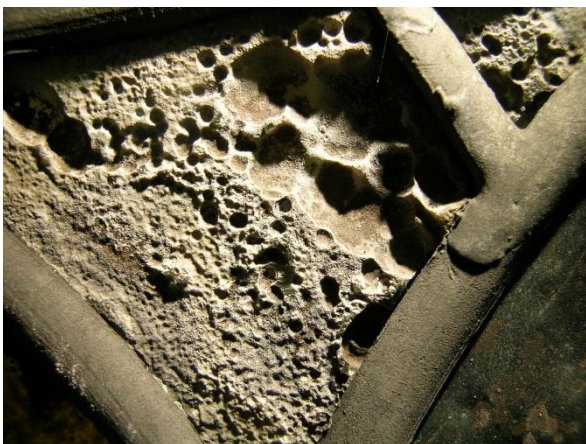
The medieval glass surfaces both internally and externally have suffered extensive and extremely damaging corrosion. Deep craters pit the surfaces, and many glass pieces have lost most of their thickness (Fig.8). All medieval glass is affected in this way. There are multiple fractures, and the painted decoration is in all stages of lost, loose, flaking and still adhering (Fig.9). The Victorian glass, too, shows deterioration: the glass surfaces are still intact, but the painted decoration is fragile and is beginning to

Fig.8: Corrosion damage – ‘pitting’

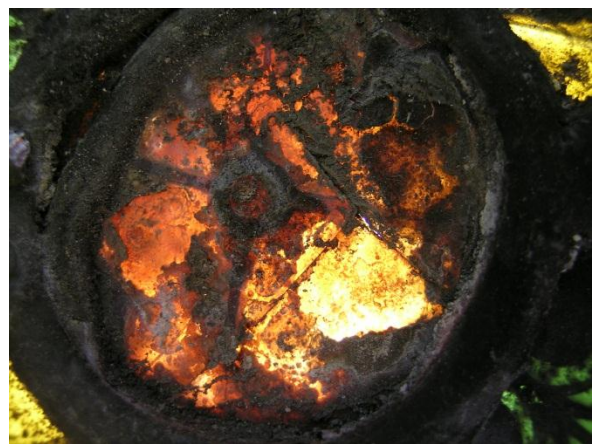
Fig.9: Corrosion damage – paint loss

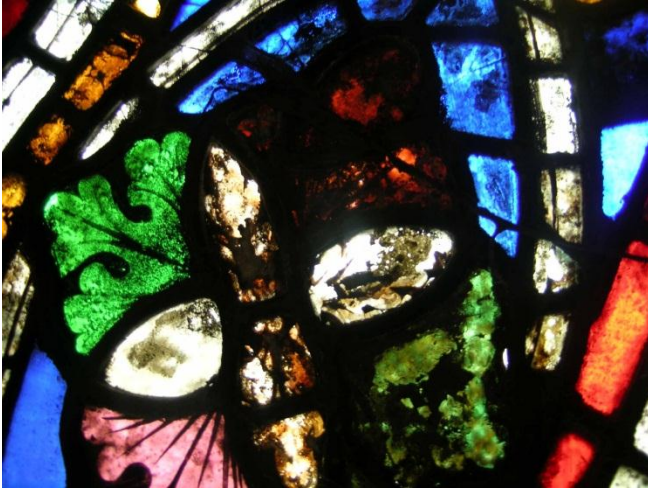
Fig.10: Medieval glass showing corrosion damage

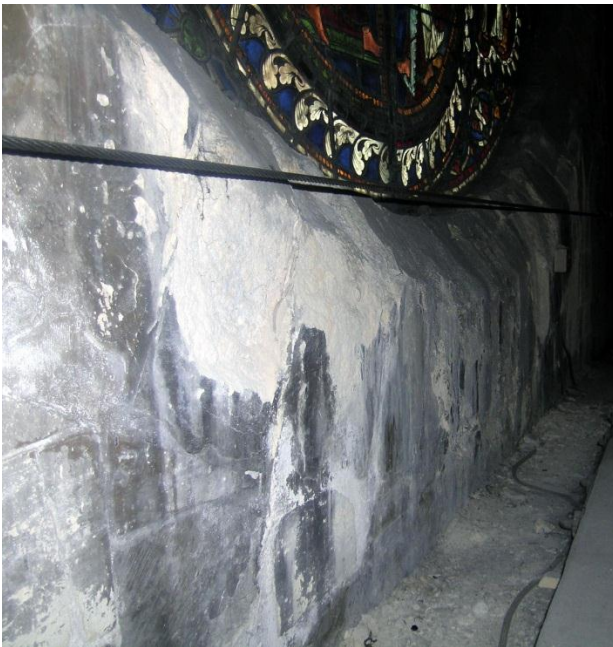
show damages. All panels are distorted and leak heavily, which is impacting the stonework surrounding the window (Fig.11).

Fig.11: Water damage to stone cill

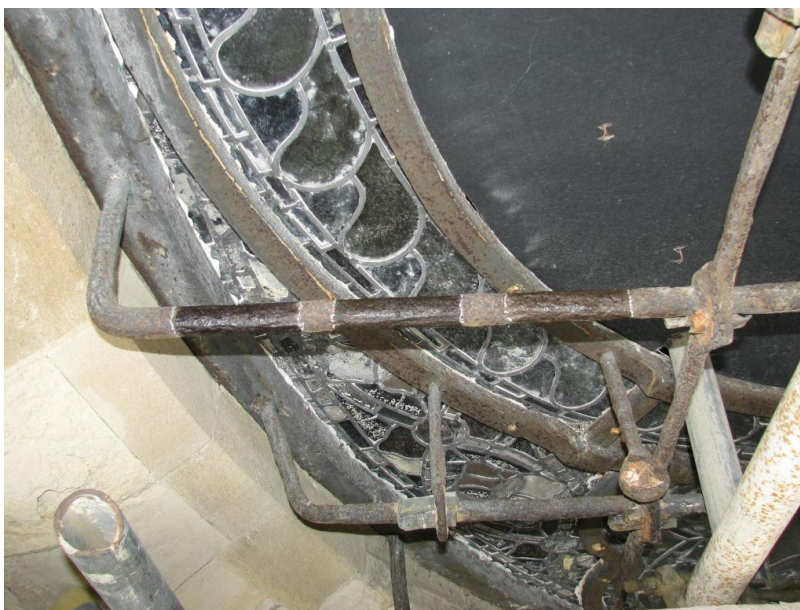
Fig.13: Cleaning and treatment trials on the metalwork

The surface treatment of the medieval iron will be carried out by a specialist metal conservation firm, following successful treatment trials (fig.13). Treatment will be restricted to very gentle mechanical cleaning, followed by a wax coating with rust inhibitors (Waxoyl).
