The South Oculus Window of Canterbury Cathedral

The preservation of a unique medieval
work of art and engineering

Leonie Seliger ACR, Head of Stained Glass Conservation, Canterbury Cathedral
6/28/2011

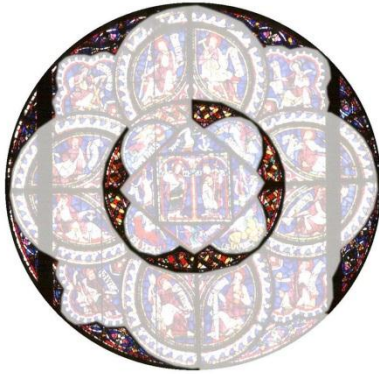
In the South Oculus, fourteen original ornamental panels survive (fig.4); the remainder is a convincing reconstruction of the iconographic scheme by the younger George Austin, based on the remaining glass in the opposite window (fig.5).

Fig.4: medieval glass

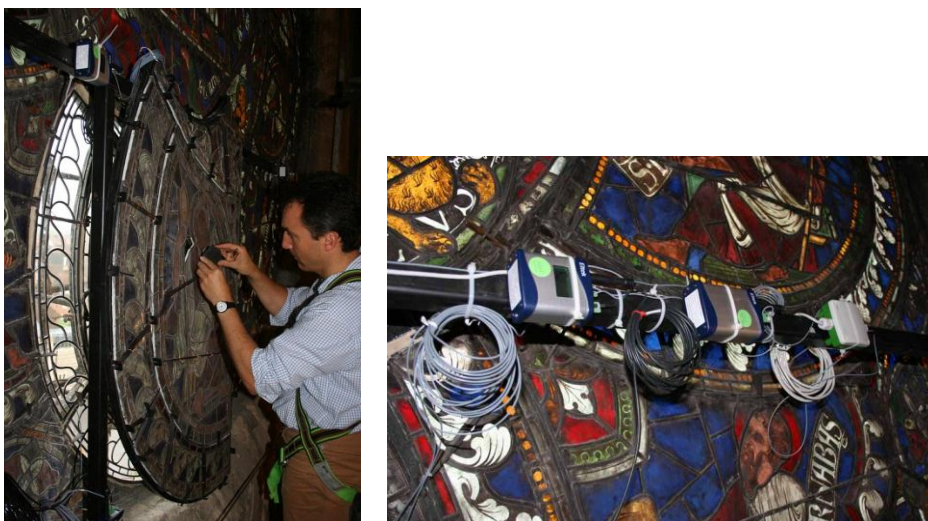
In 2007 and 2008 a study was carried out over a period of 18 months by environmental monitoring specialists TC Associates Ltd. to evaluate the effectiveness of the existing protective glazing system on the North Oculus, and to investigate if the system will work well for the South Oculus. A sample section of the South Oculus window (fig.12) was removed from the original frame and set into a temporary sub-frame behind protective glazing. A wide range of data was collected over an eighteen month period. The results were then compared with data taken from the equivalent unprotected section of the same window.

Fig.12: Data collection on test section
